Balloon Cave visit and assessment, Carnarvon Gorge, Queensland

Fieldwork Report, 7 February 2019

Paul S.C. Taçon

PERAHU, Griffith Centre for Social and Cultural Research

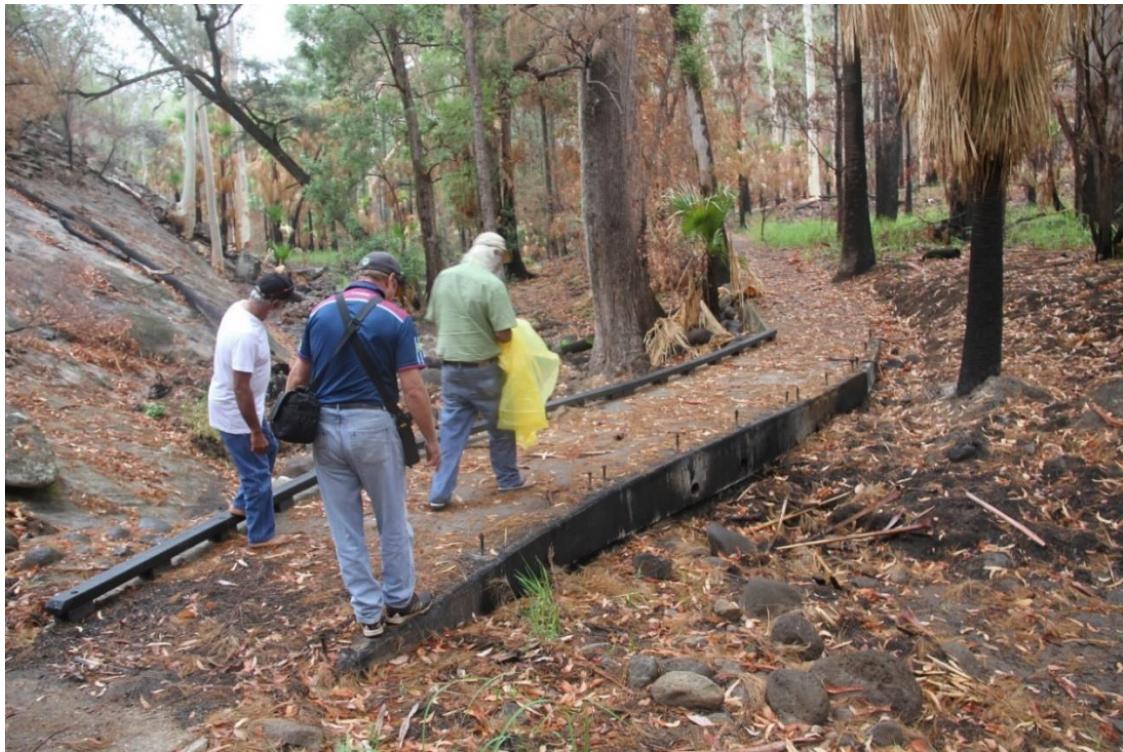
During the visit we inspected the walkway infrastructure leading up to Baloon Cave, including the remains of both recycled plastic and wooden walking tracks and bridges (Figure 4). One of our first observations was that the recycled plastic infrastructure was badly burnt and melted but much of the wooden infrastructure, although blackened, was largely intact (Figure 5).

Figure 4: The plastic guardrail on the right that once was in the fire's path burnt and melted.

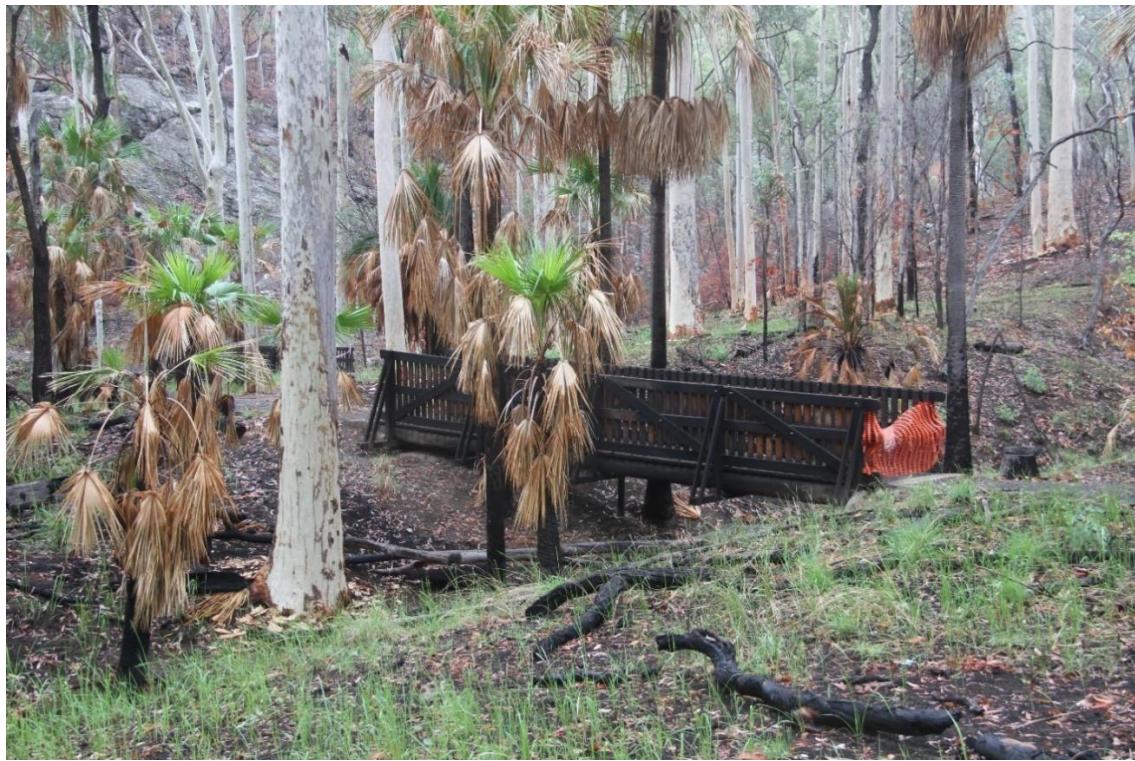
Figure 5: Wooden bridges, although scorched, survived largely intact, unlike plastic infrastructure.

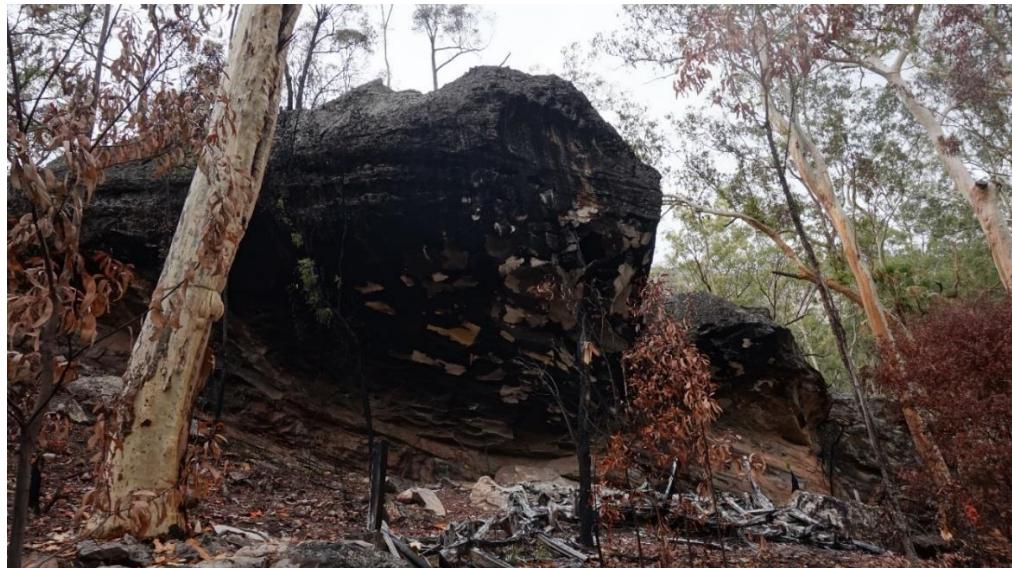
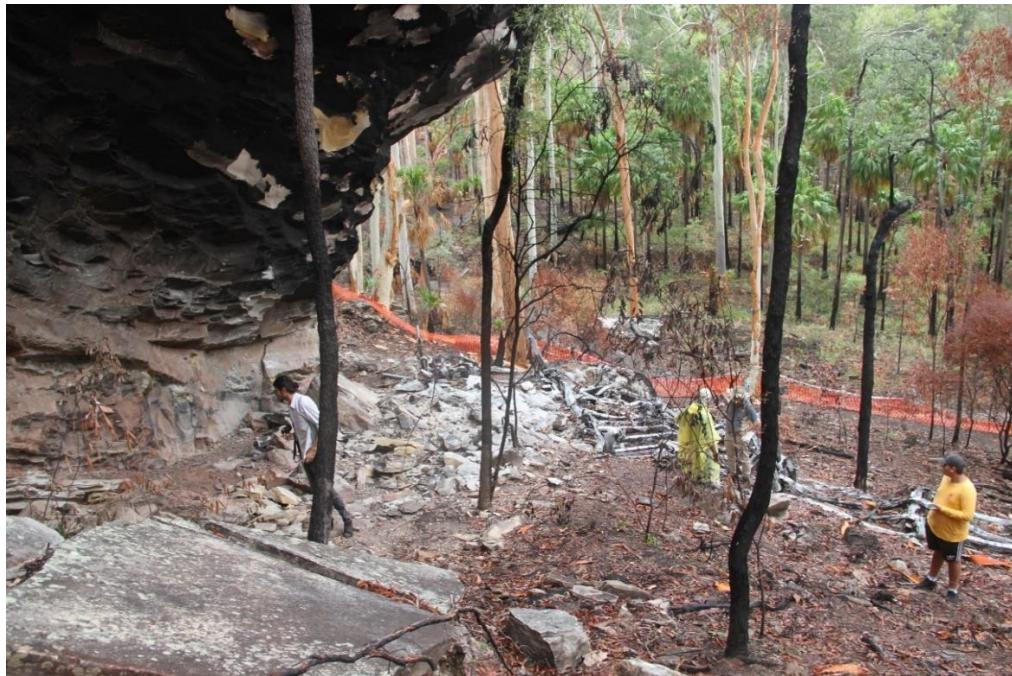
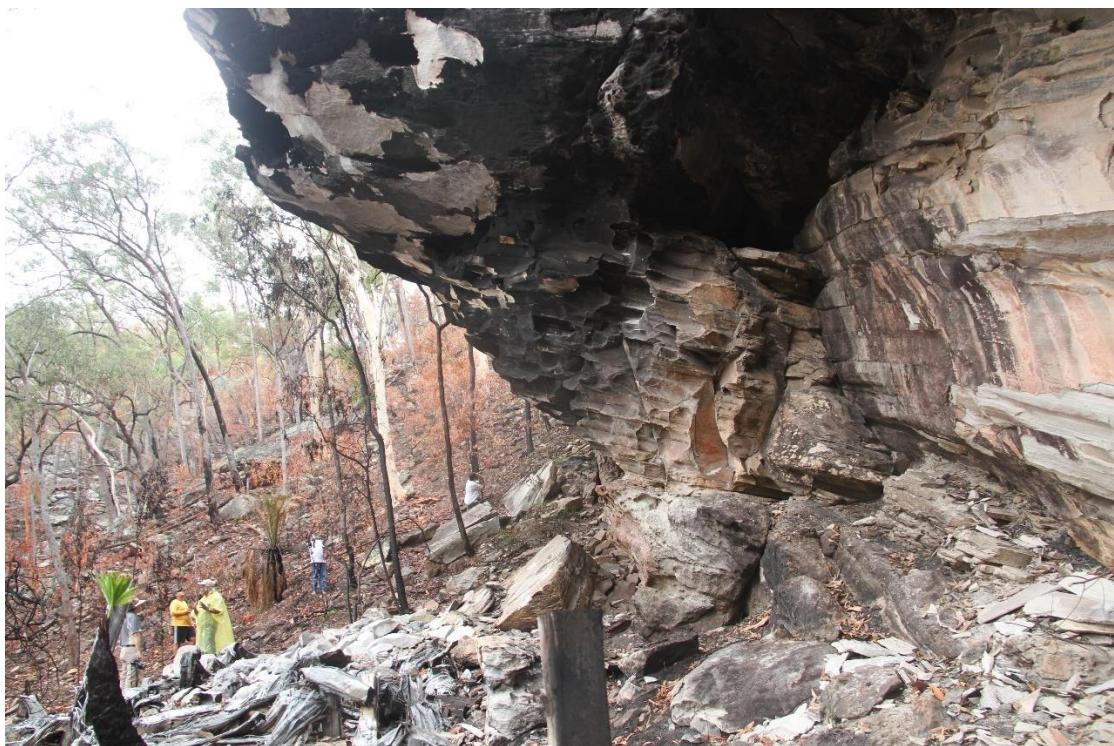
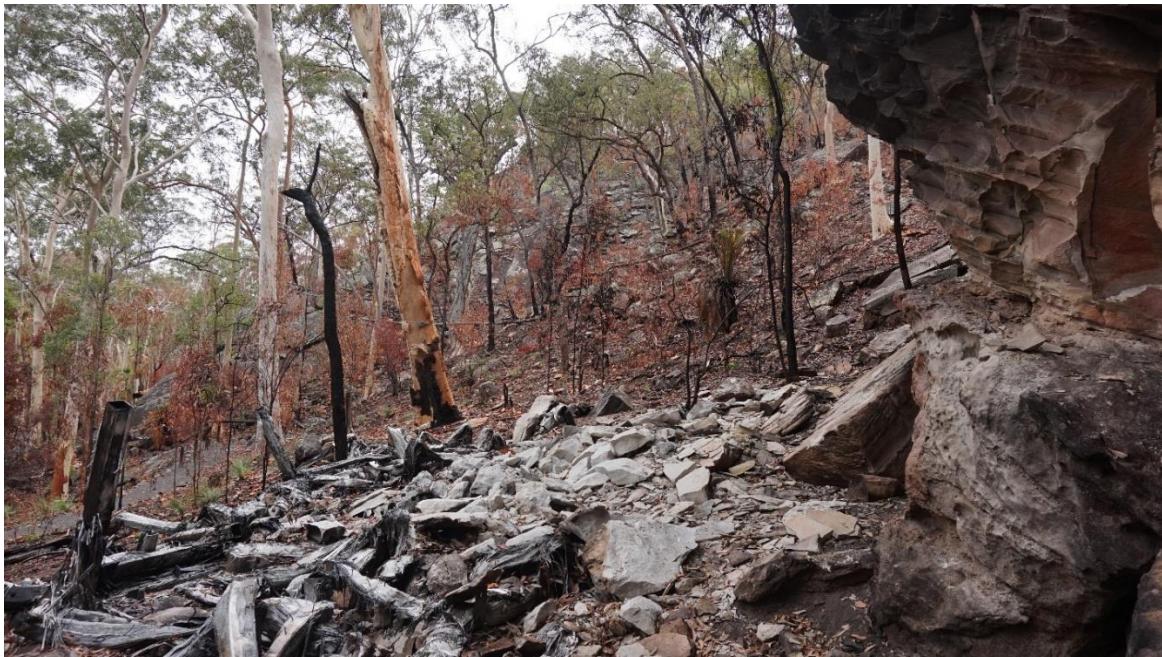
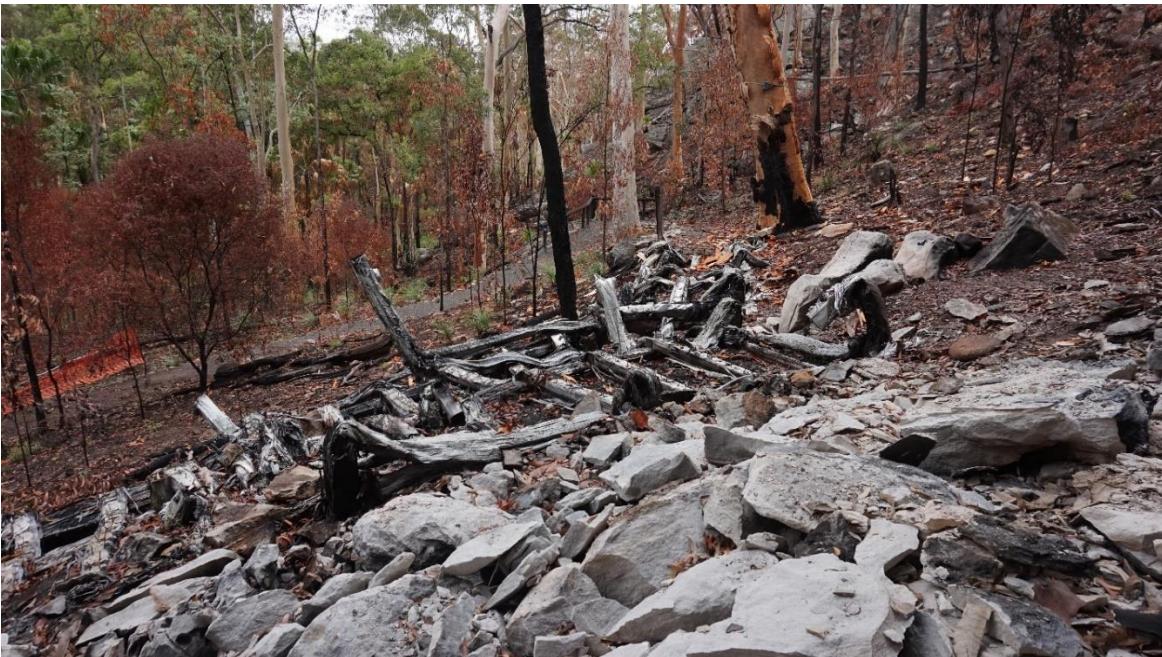
The fire was particularly devastating where the viewing platform and walkways leading up to it once stood. This infrastructure was completely destroyed, severely damaging the rock shelter in the process. The heat must have been very intense as much of the rock shelter surface exfoliated and collapsed. Black soot covers remaining parts of the shelter wall and ceiling (see Figures 6-11).

Figure 6: View of Balloon Cave after the fire facing into the shelter.

Figure 9: View of the shelter from the right after the fire.

Figure 10: Baloon Cave where the viewing platform once stood with collapsed wall on floor.

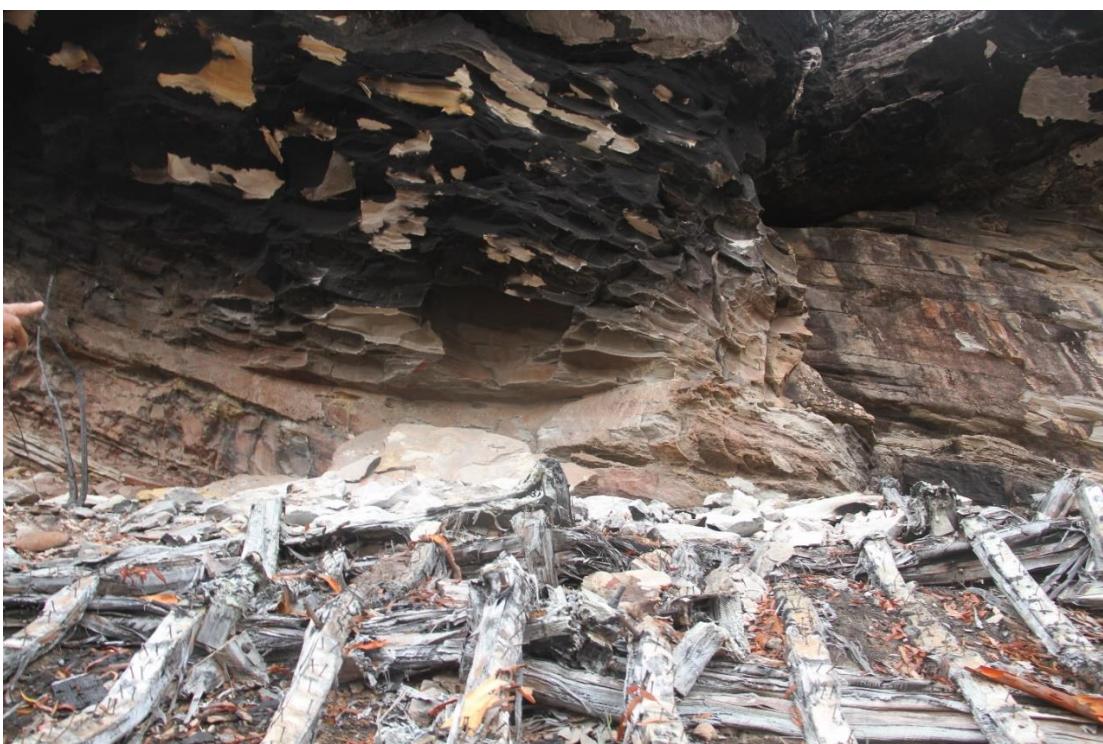
Rock art at the site was heavily impacted. Damage to the main panel consists of exfoliation to the left, right and above right; cracking at the upper right; and a coating of soot over most of the stencilled hands and all of the hafted axe stencils (see Figures 12-14). As one approaches

Figure 13: After the fire. At first the main panel (centre) appears totally blackened.

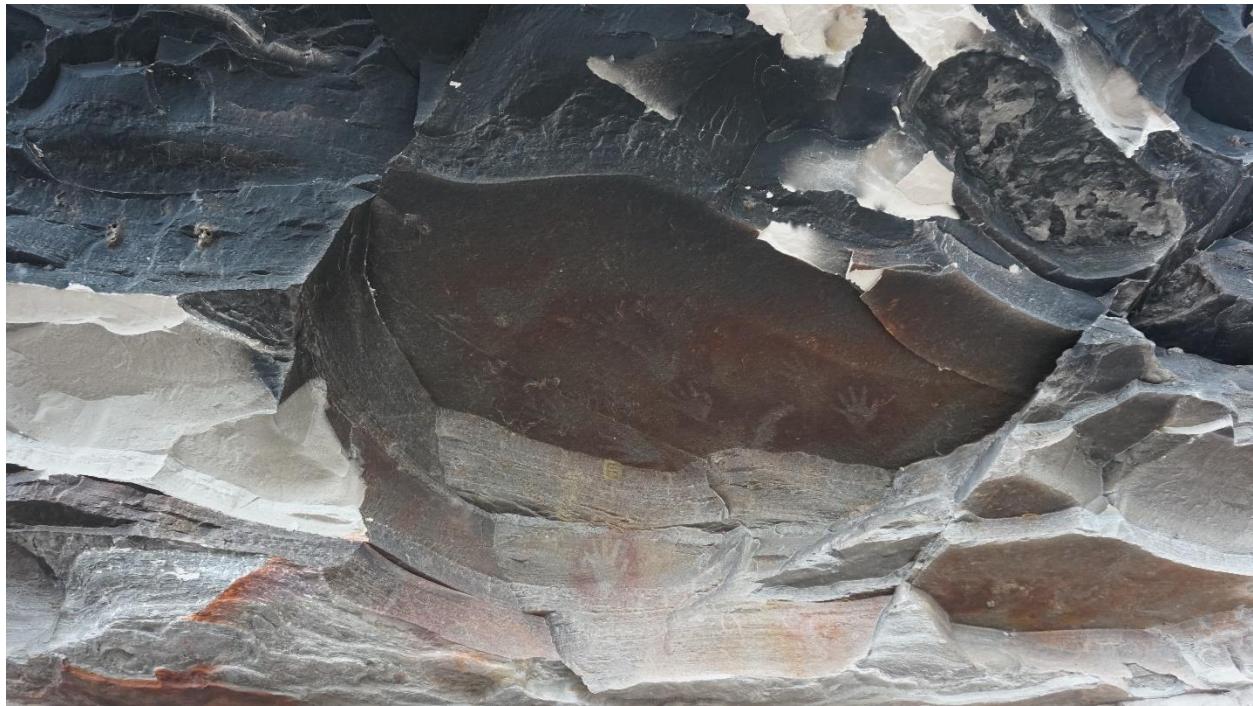
Figure 14: Damage to the main stencilled panel consisting of exfoliation, cracking and soot.

5. Paul Taçon should consult rock art conservation experts as to whether the soot coating over the main panel of stencils can be removed and the panel consolidated without doing further damage. If the community agrees the first action might be an off-art test of soot removal. Fred asked if chemicals would be used but hopefully all that would be needed is water, perhaps applied with cotton buds and/or a special cloth.

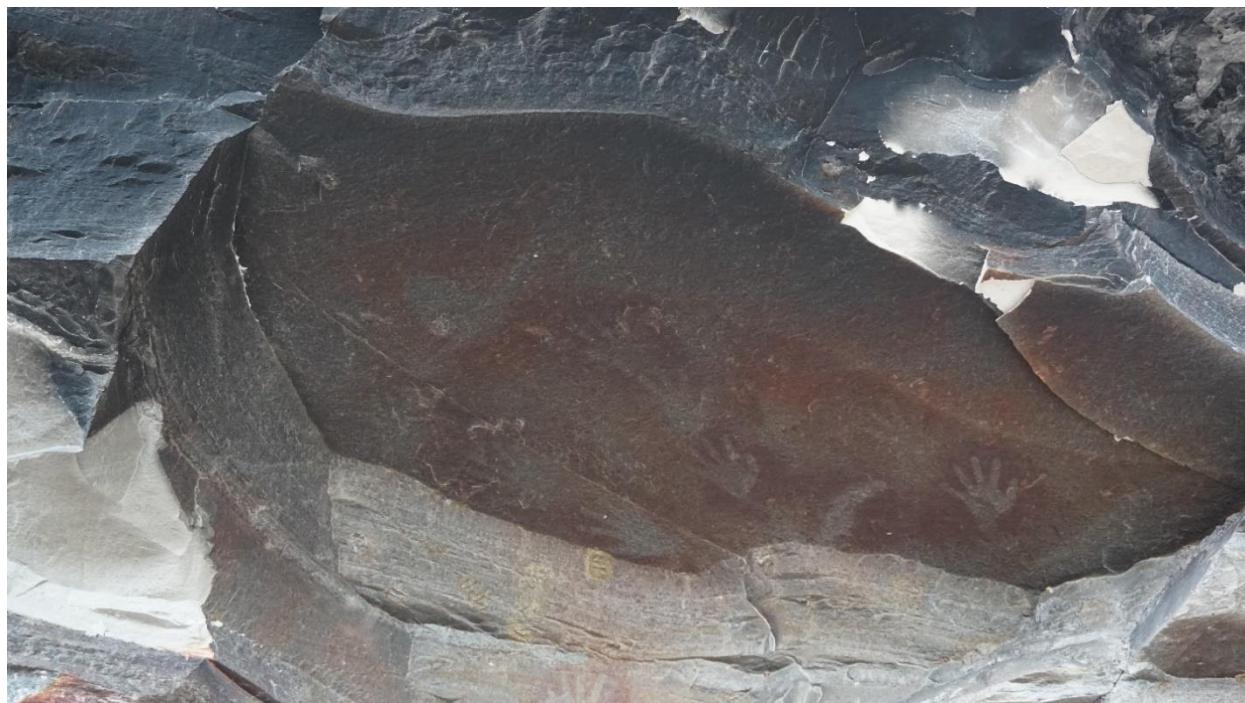
Damage to the rare hafted stone axe stencils is pronounced as not only have they been blackened but also where two of them are located the rock has both cracked and exfoliated. The cracked portion at the left looks as if it could easily collapse (see Figures 15 -16). It may be possible to remove the soot and to consolidate the panel but this needs further investigation and assessment (see recommendation 5 below). Should it be decided to attempt this it should be undertaken cautiously, so as to not create new damage. More generally, physical intervention at rock art sites should always be a last resort, carefully considered and undertaken only by knowledgeable/experienced professionals.

Figure 16: Baloon Cave main stencil panel after the December 2018 fire.

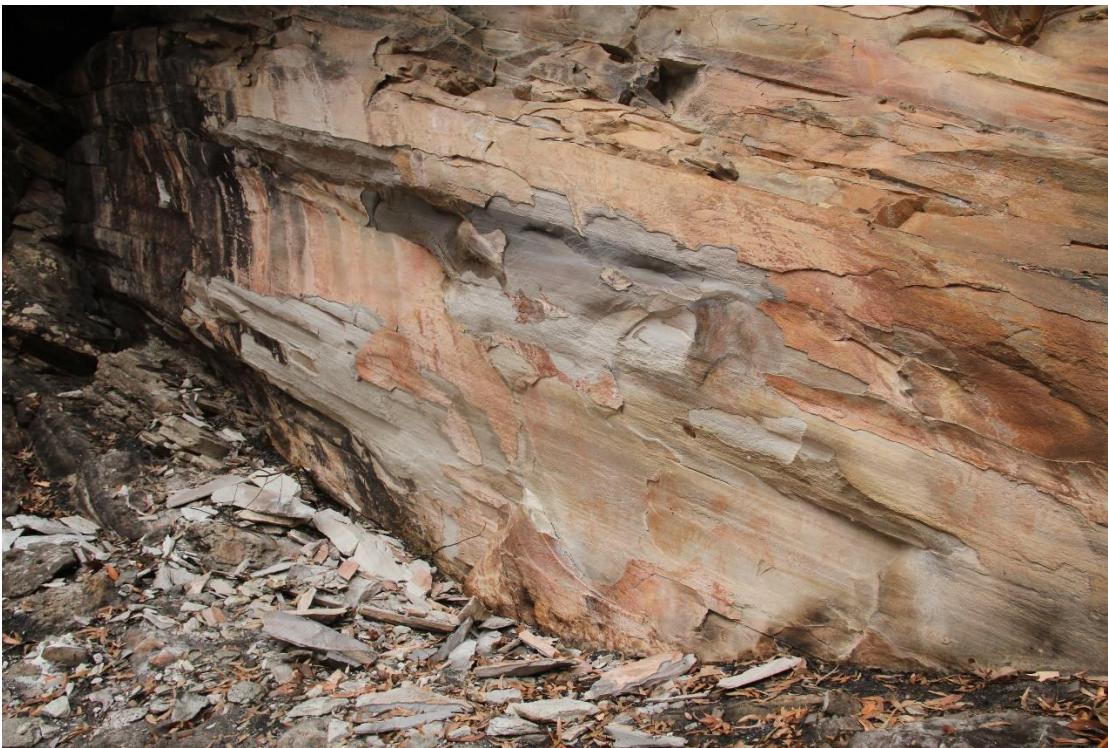
The lower right side panel has suffered from exfoliation but not as much soot damage.

Figure 18: The lower right panel after the fire.

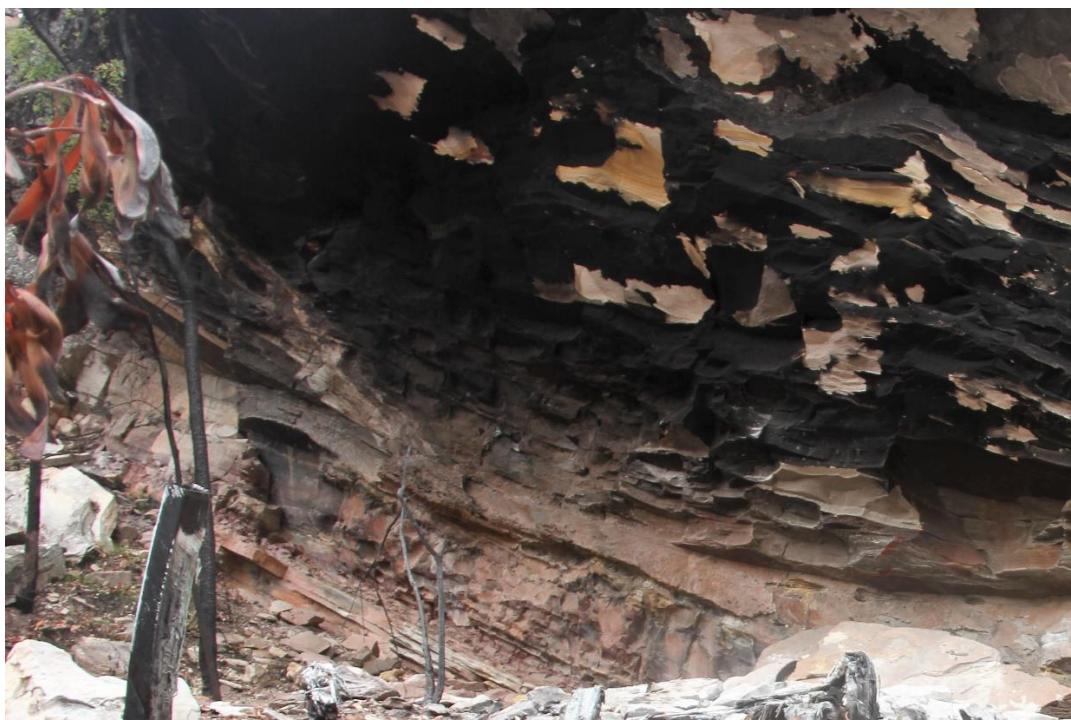
The lower left side has suffered some soot damage and exfoliation high up.

Figure 20: The left side after the fire. Some hand stencils are covered in soot.

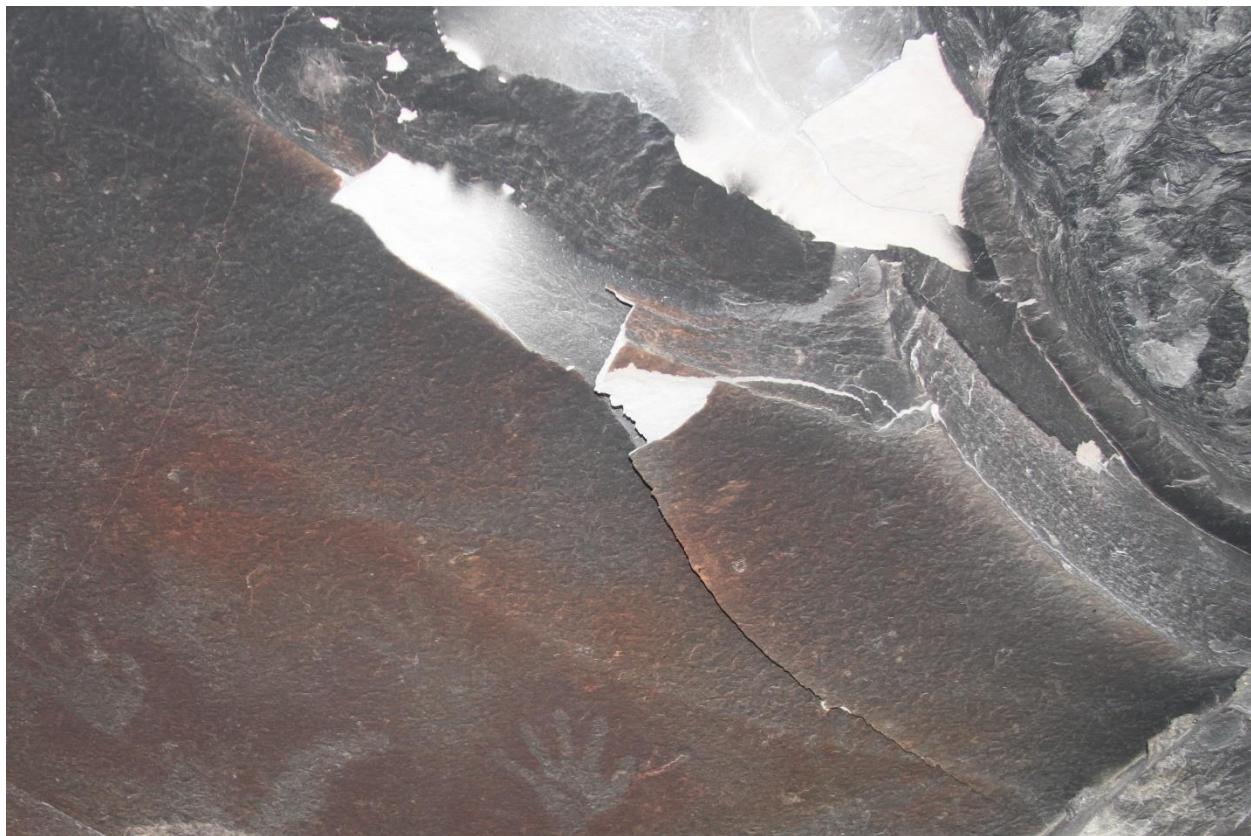
At Baloon Cave, the main central panel, once immediately above the viewing platform, suffered the most damage, especially to two of the three hafted stone axe stencils (Figure 24), with a covering of soot, exfoliation and cracking. There is a risk that the rock above the major new crack could sheer off and fall to the ground, taking portions of the stencils with it. It also poses a

health and safety risk to visitors, staff and contractors rehabilitating the site, as well as conservators addressing both this issue and the soot over the panel in the future.

Figure 24: Close-up of area of damage to the hafted stone axe stencils.

Rock art conservators should be employed by QPWS to undertake a detailed conservation assessment and to decide what remedial action could be implemented. Previous interpretative material installed at the site was excellent (e.g. Figures 25 and 26) but if the site is reopened to the public, and considering what happened, then very different new interpretive material will need to be developed in consultation with representatives of the Aboriginal community.

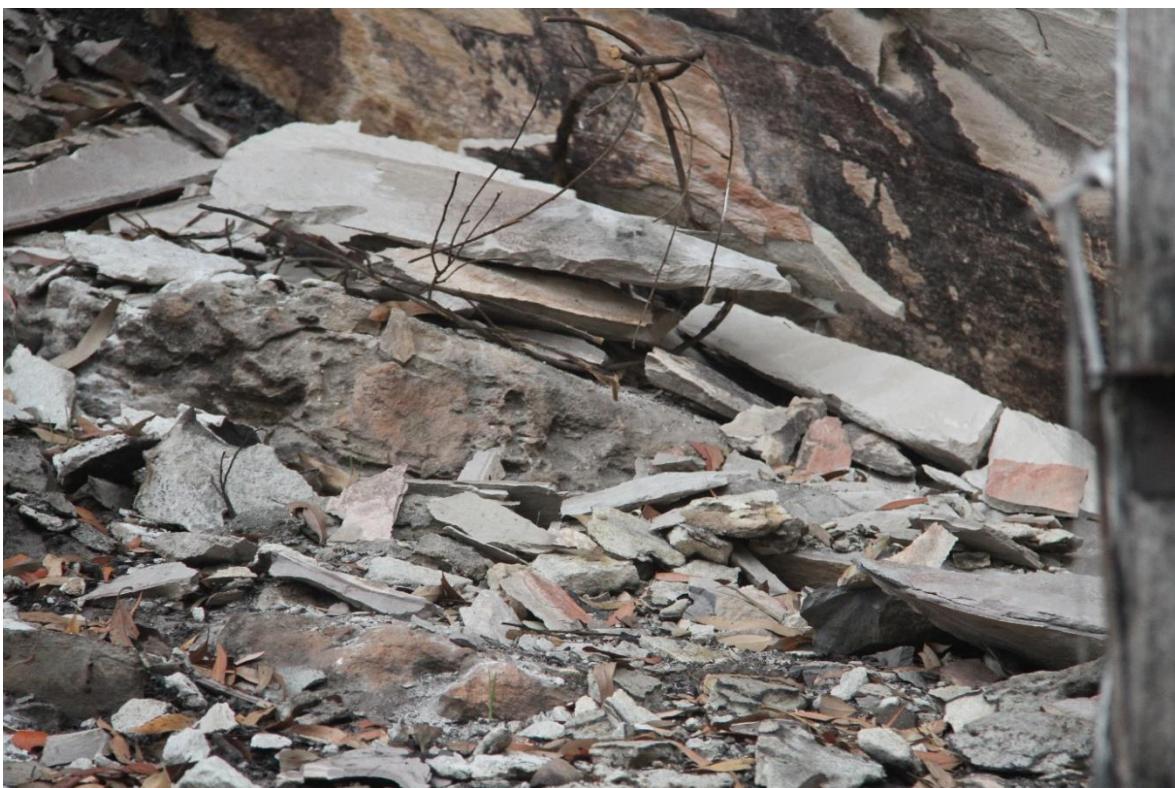
Figure 30: Results of exfoliation.

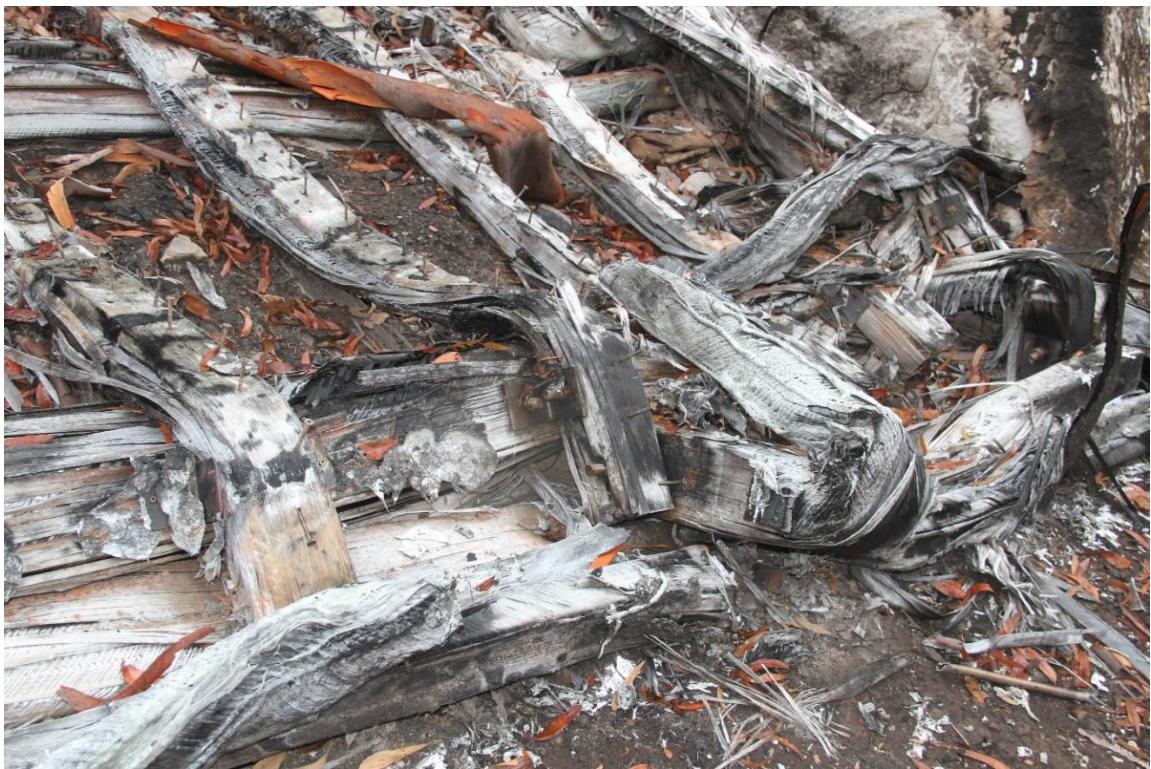
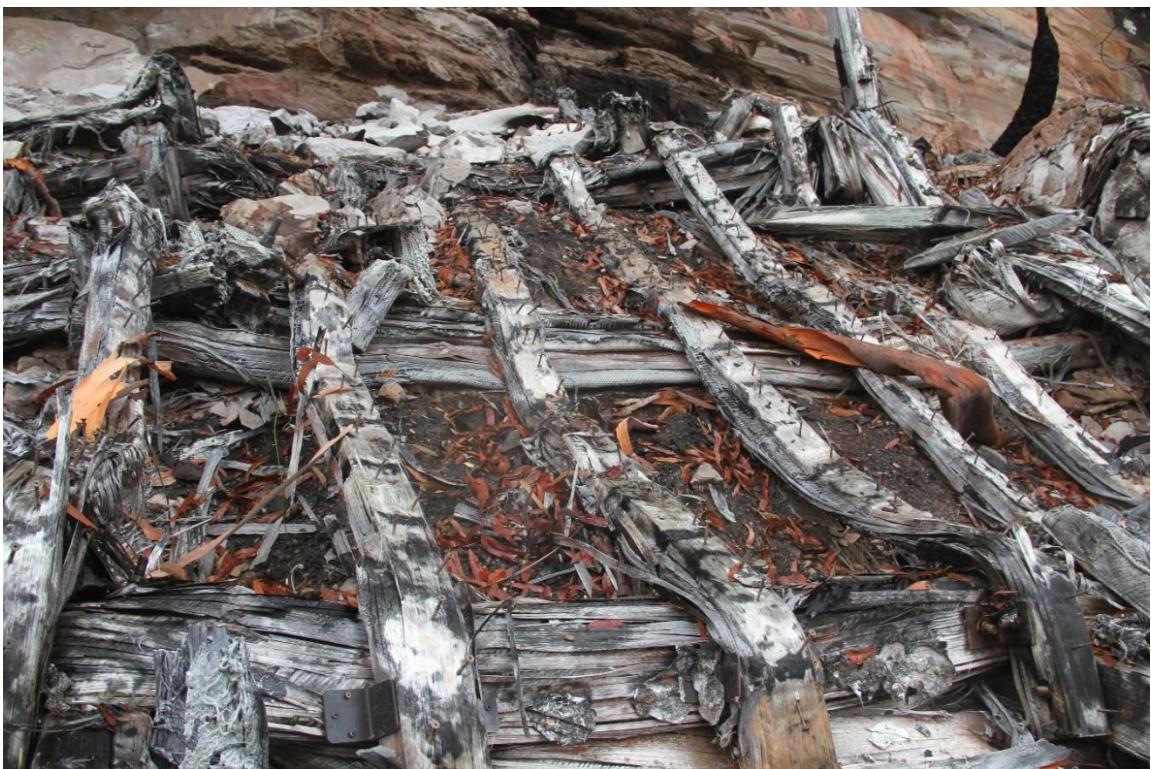
Figure 31: Remains of viewing platform structural components.

3. The clean-up of the site and removal of the remains of the walkway and viewing panel should only be undertaken with appropriate Aboriginal community members present.

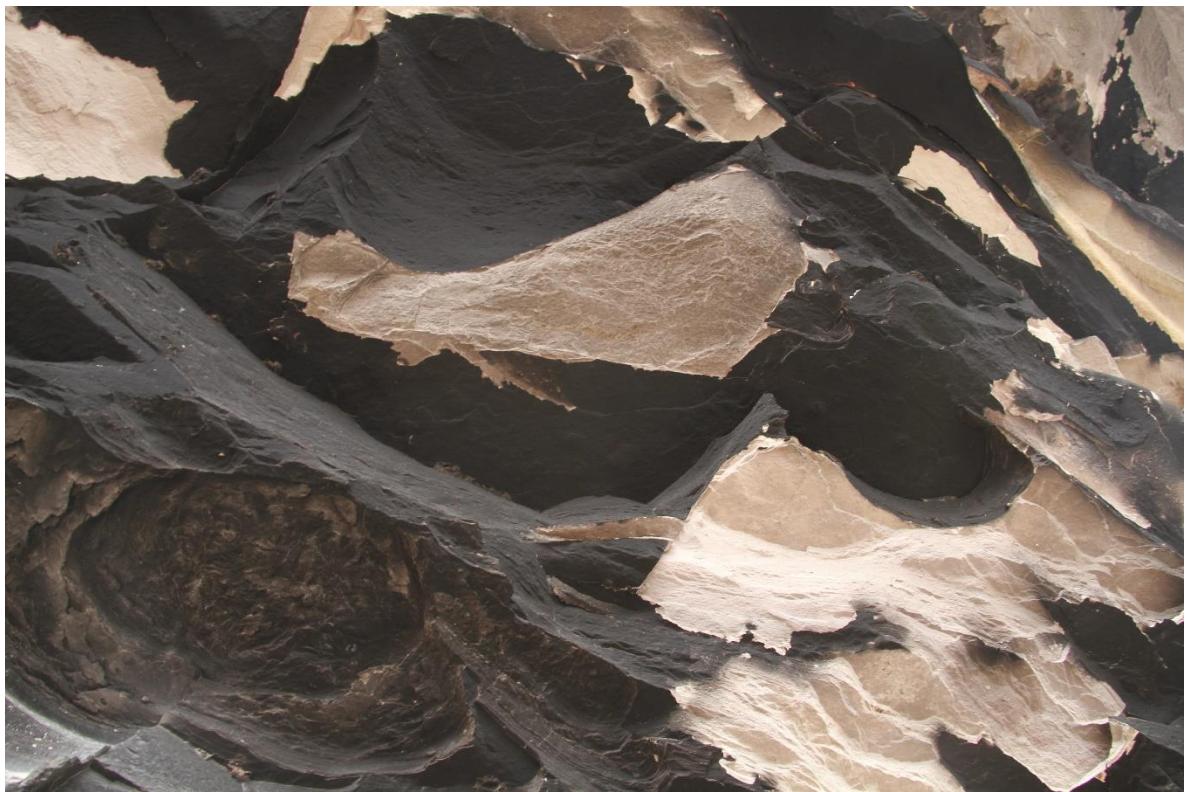
Figure 34: Exfoliation of the ceiling.

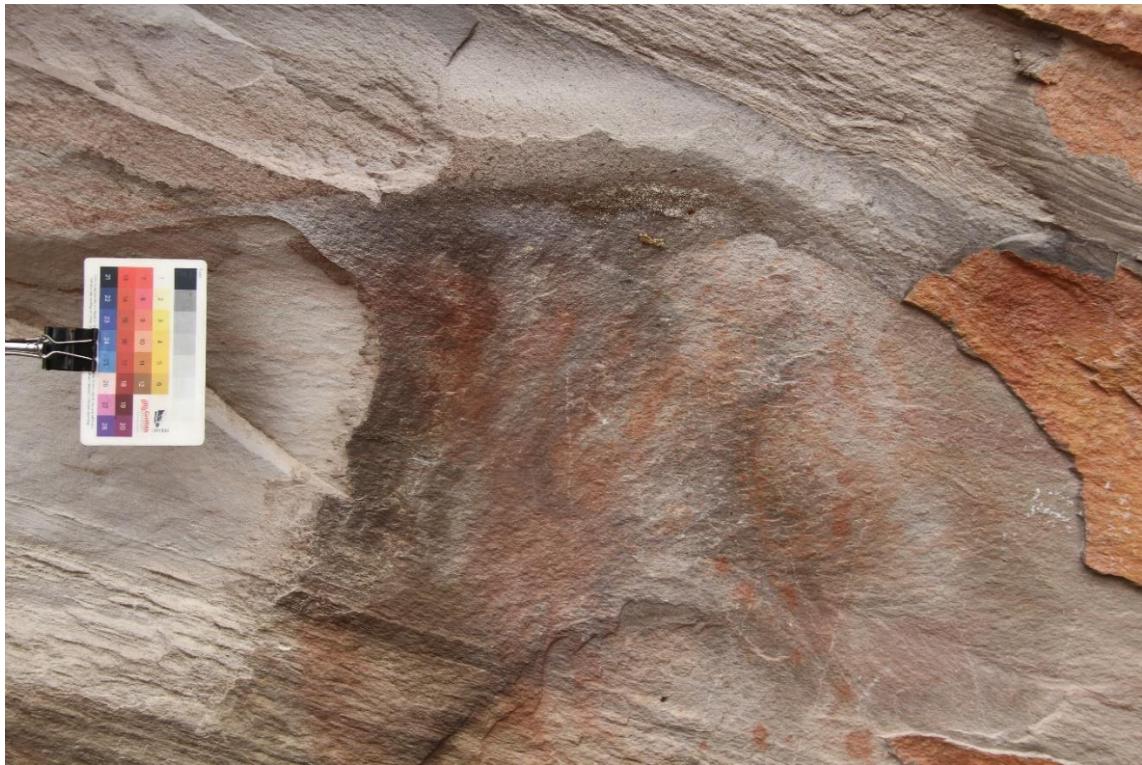
Figure 35: Scratched graffiti and vandalism over stencils made prior to the fire.

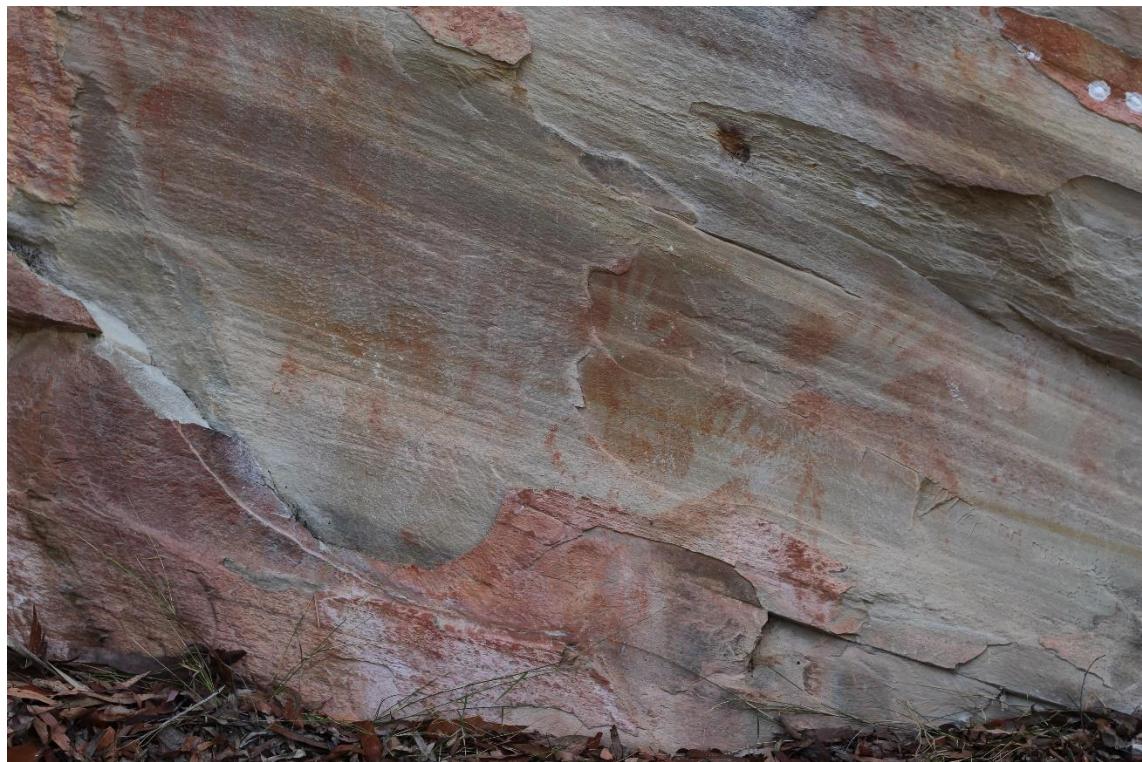
Figure 36: Scratch marks over hand stencils prior to December 2013 (photo: Dale Harding).
